A Chicagoland / Lake Michigan AS-40 Tale – 2016

Submitted by Jay Grizzell, *Shoe String*, a 1989 Olson 34

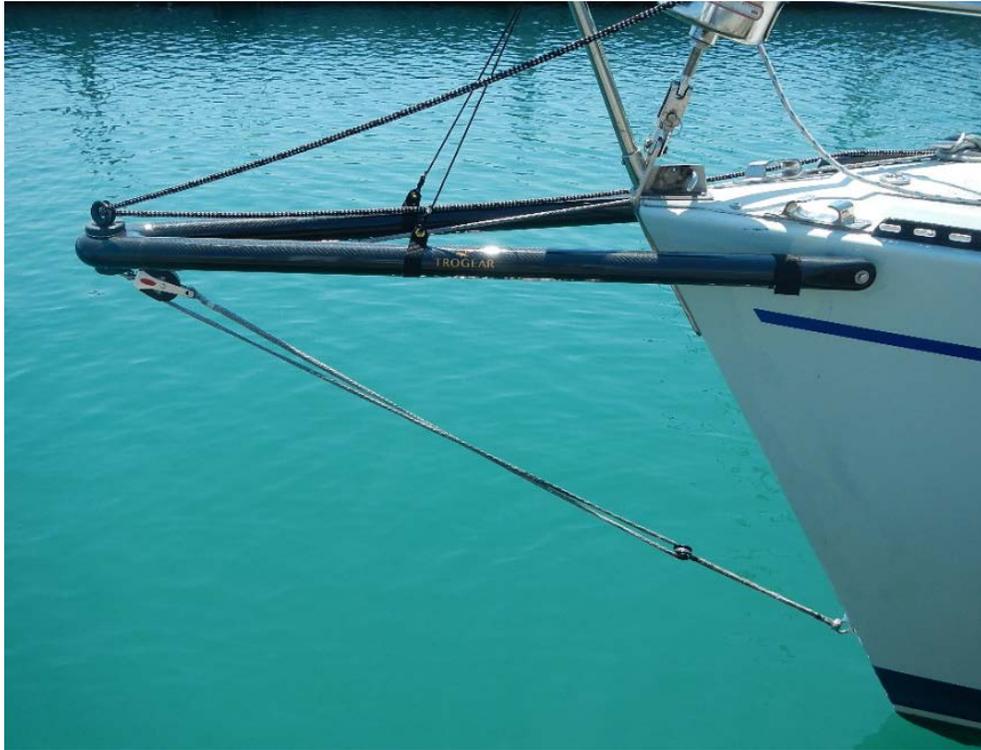
Port Side View

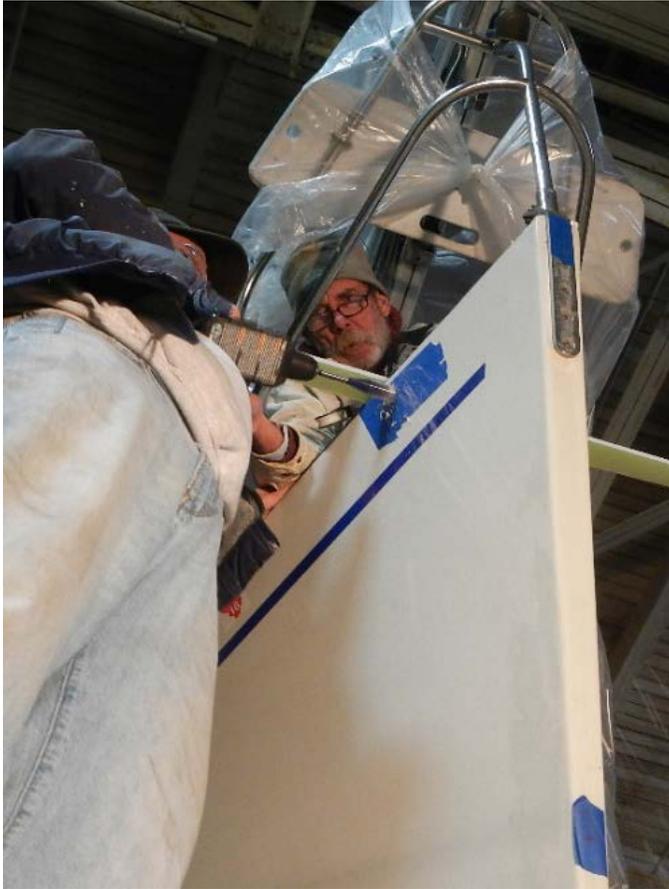
The moment of truth! Drilling!

With assistance from the 'sweat equity crewmembers', we measured, dry fit, measured again, taped and prepped for the most important (and nerve-wracking) procedure: drilling (2) 1" diameter holes into the hull. The dry fit procedure verified where the AS-40 would mount relative to the toe rail. Crawling, inverted, inside and past the forward bulkhead to confirm there were no obstructions to the intended location was an important fail-safe.

We 'measured thrice and drilled twice', using a brand new 1" diameter drill bit that included a small pilot auger. We used a straightedge to align the drill, which also had a level. The hull on an Olson in this area of the bow is only @ 5/16" thick and offered little resistance to the drill bit.

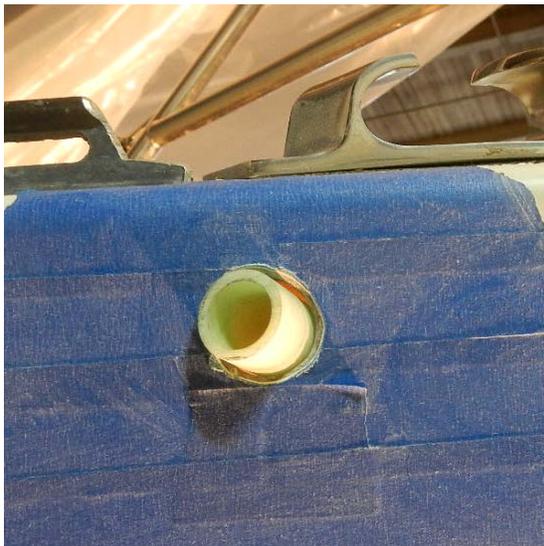
Prepped and ready to epoxy

Index marks on the exposed 1" D fiberglass tube were drawn, assuring that the exposed port & starboard dimensions were equal.

Prior to installation of the tube, the inside cavity of the bow was illuminated so the fiberglass area around the 2 holes could be wire brushed and wiped with acetone, so the 1" fiberglass tube could be secured to the hull by additional "peace of mind" strips of epoxy impregnated fiberglass tabbing.

Epoxy was mixed, the 1" D fiberglass tube inserted and epoxied into position and finished with a 'finger fillet' both inside and out. Crawling into the bow to fillet the interior took more time than the entire exterior procedure.

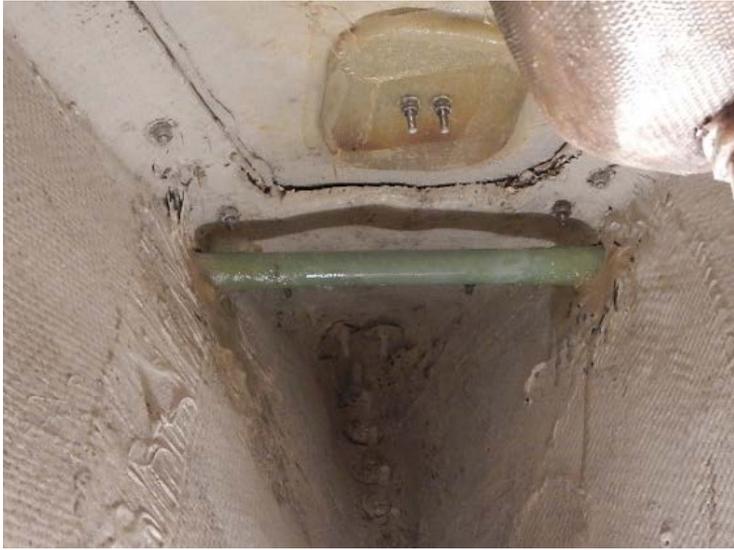
Tabbing of tube within the bow cavity

Once cured, the interior tabbing was completed. The exterior union received a treatment of structural fairing

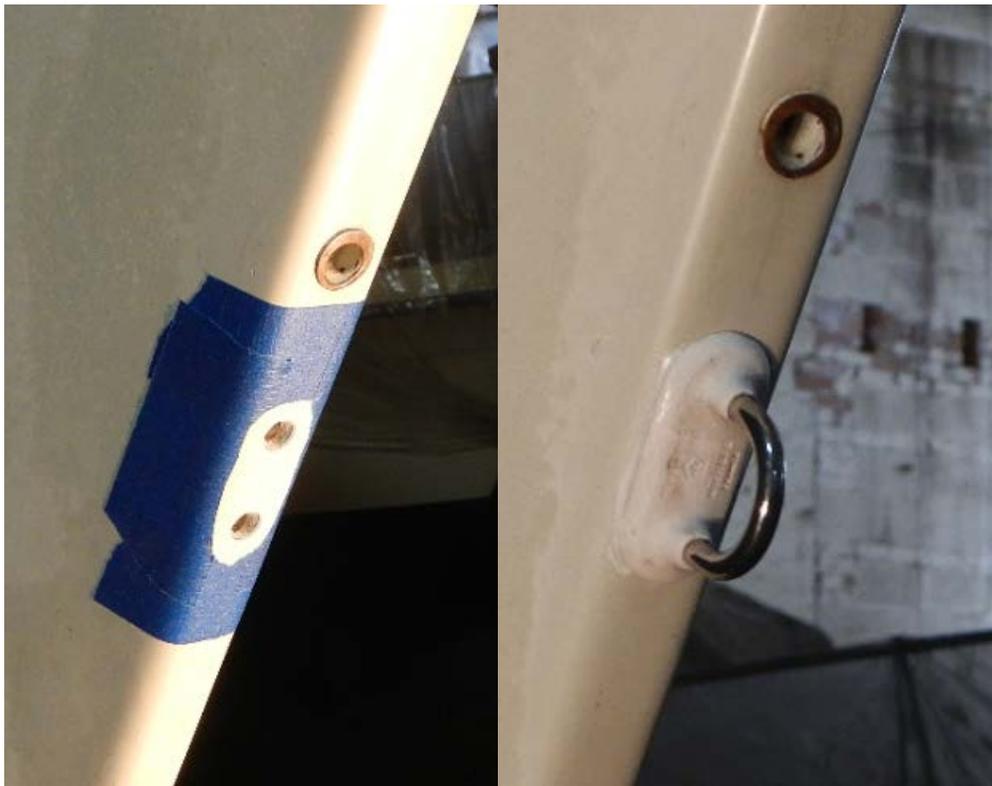
U-bolt location prepped and installed

The U-bolt location for the bobstay was verified, 2 holes drilled and the Wichard Watertight U-bolt installed.

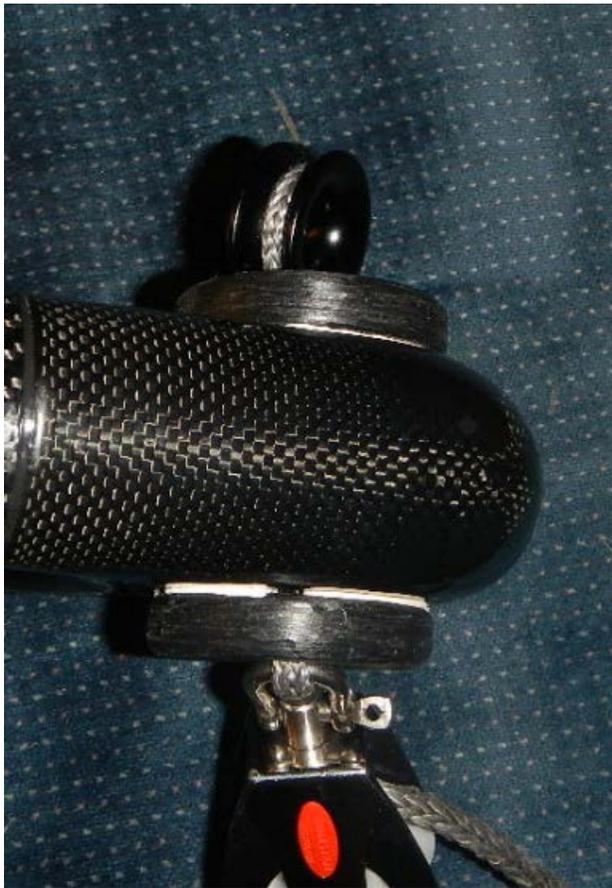
Top and bottom black marine board donuts to buffer the friction ring (top) and shackle (bottom)

Black donuts of marine board were fabricated to prevent damage to the sprit from contact by the Ronstan Low Friction rings. These were installed, this season, with butyl tape. Next season they may be secured via some form of adhesive caulk, in an effort to hold them in a fixed position.

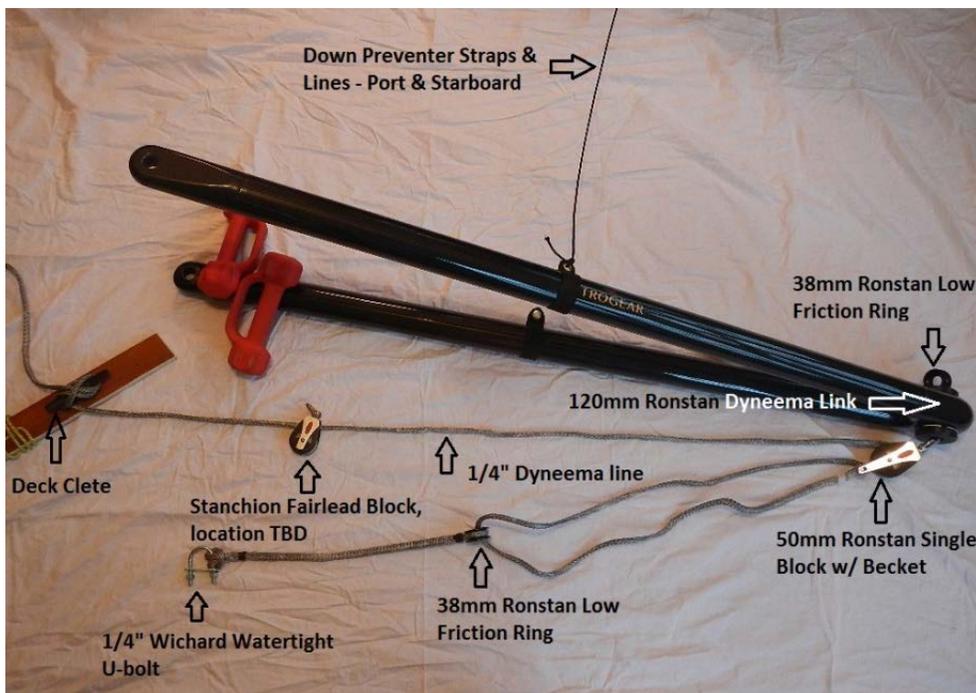
AS-40 and bobstay components as built 2016

Countless hours were spent to design, verify and procure the components necessary for the bobstay, as each boat has different needs and bow designs. It's believed the design arrived at in this case combines simplicity, ease, function and economics.

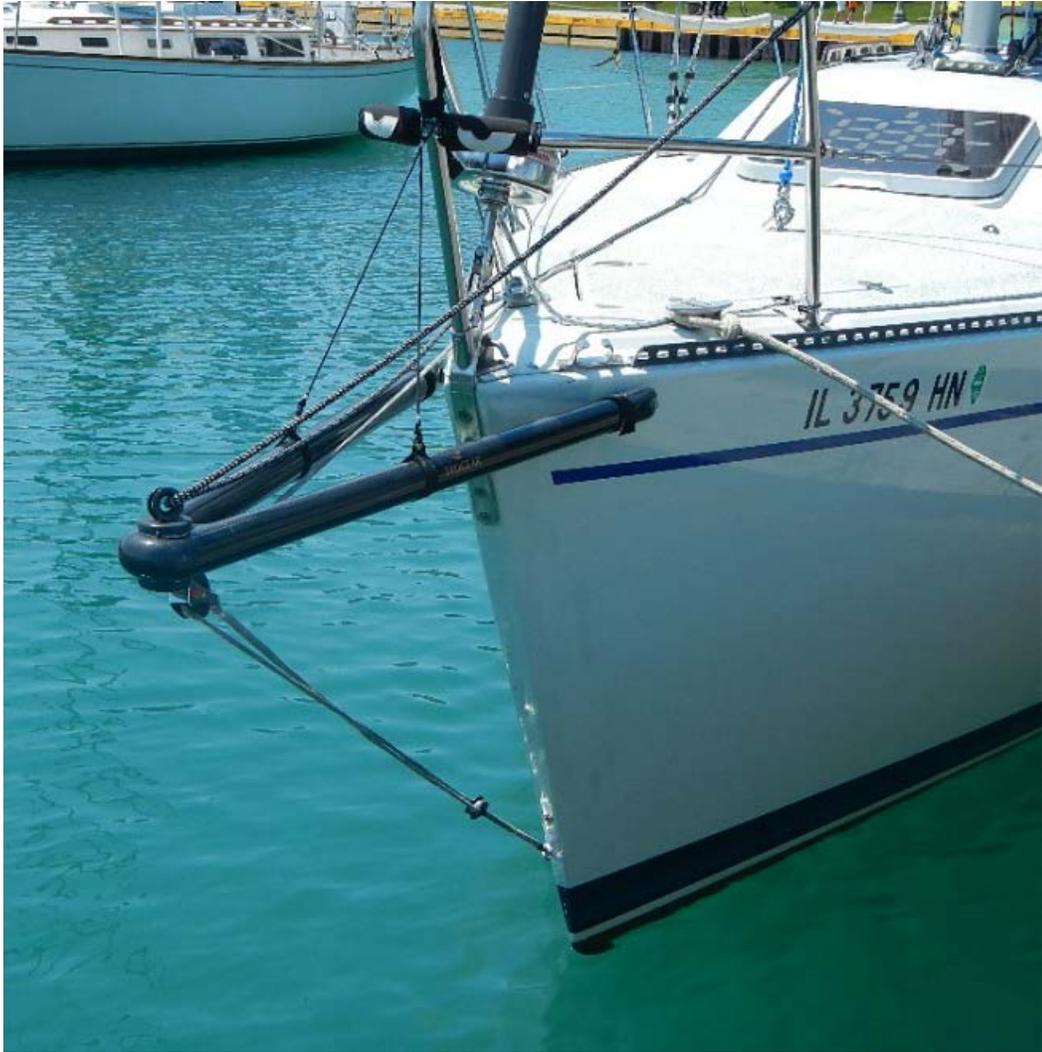
Bow view
